Original Research Article

Retrieving and Documenting the Changes in the Form and Function of Sheikh Lotfollah Monument Based Upon Descriptive and Visual Documents and Oral History Studies

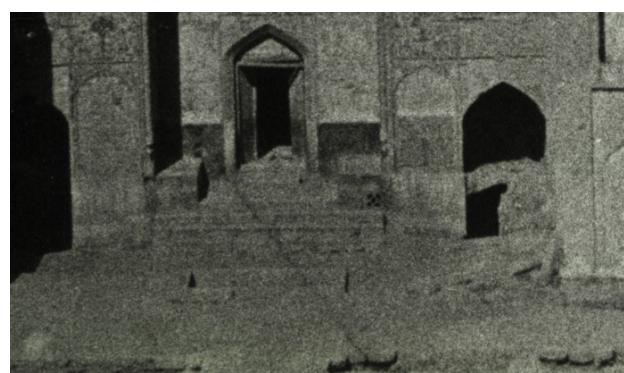
Fig.1.Unknown. The destroyed pond in front of Sheikh Lotfollah. Source: Author's Archive.

was renovated with some changes in the plan and openings. The changes applied to this floor made a new circulation in the building, which is very different from the original one. The changes on the second floor were mainly documented based on field surveys ([Fig. 8](#)). It should be added that the decorations of Muqarnas on the porches of the second floor, which had a lot of damage, were completely restored and reconstructed in 1961. Other changes can be seen at the counter of the Sheikh Lotfollah monument. The removal of the pond in front of the building between 1937-1939 is one of the mentioned changes. Some documents wrongly mentioned the pond as octagonal shaped ([Nikzad Amir Hosseini, 1954, 112; Rafiei Mehrabadi, 1973, 698; Norouzi, 2001, 2](#)). While, in many of the remaining historical drawings and photographs, there is a rectangular pond in front of it ([Figs. 1 & 2](#)).

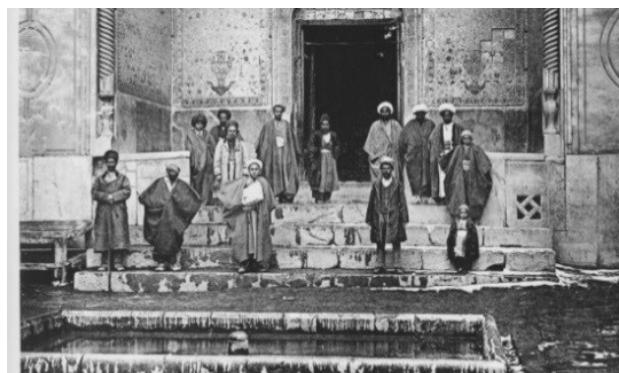
Fig. 2. Friedrich Paul Theodor Sarre. The destroyed pond in front of Sheikh Lotfollah. Source: Sarre, 1901.

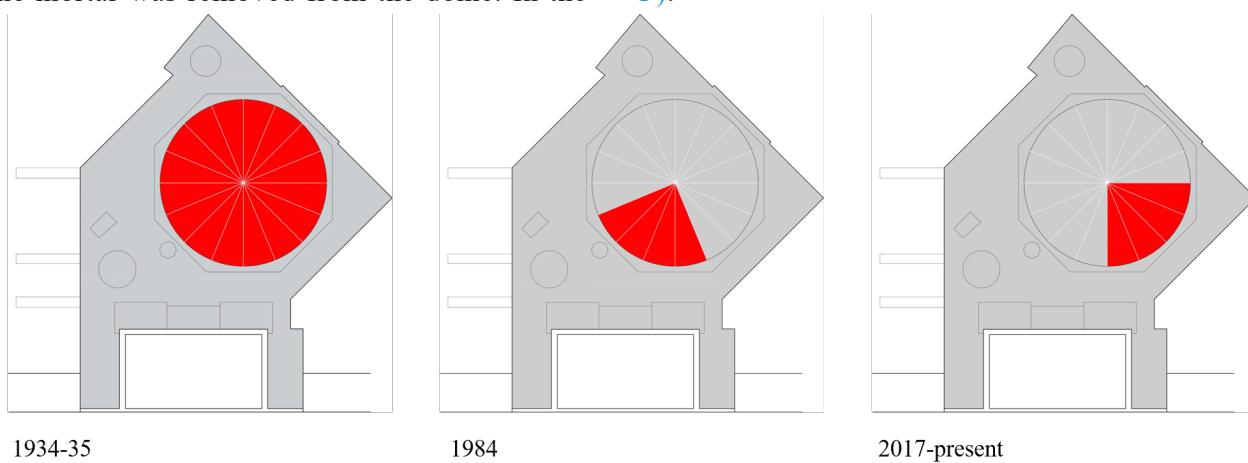
[Fig. 3. The restored lunes of the dome over time. Source: Authors.](#)

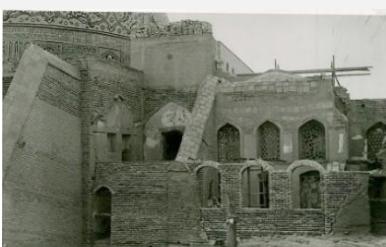
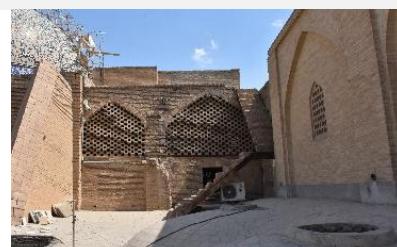
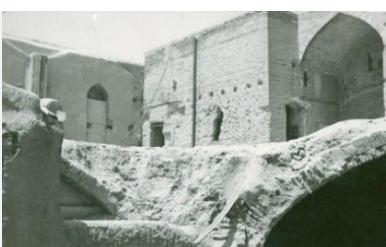
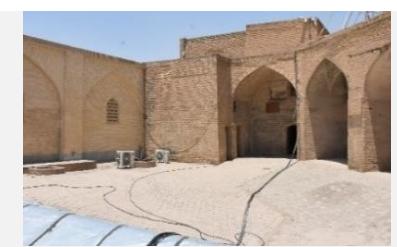
Table 5. Changes in the other façade of Sheikh Lotfollah. Source of images of Cultural Heritage Documentation Center. Source: Authors.

North facing rooms

South-facing rooms and collapsed roof of Naghshkhane

large drainage channel that did the air circulation to a prayer hall caused humidity problems in the building. Therefore, in 1985, a drainage channel was built in the northeastern part of the building ([Table 5](#)).

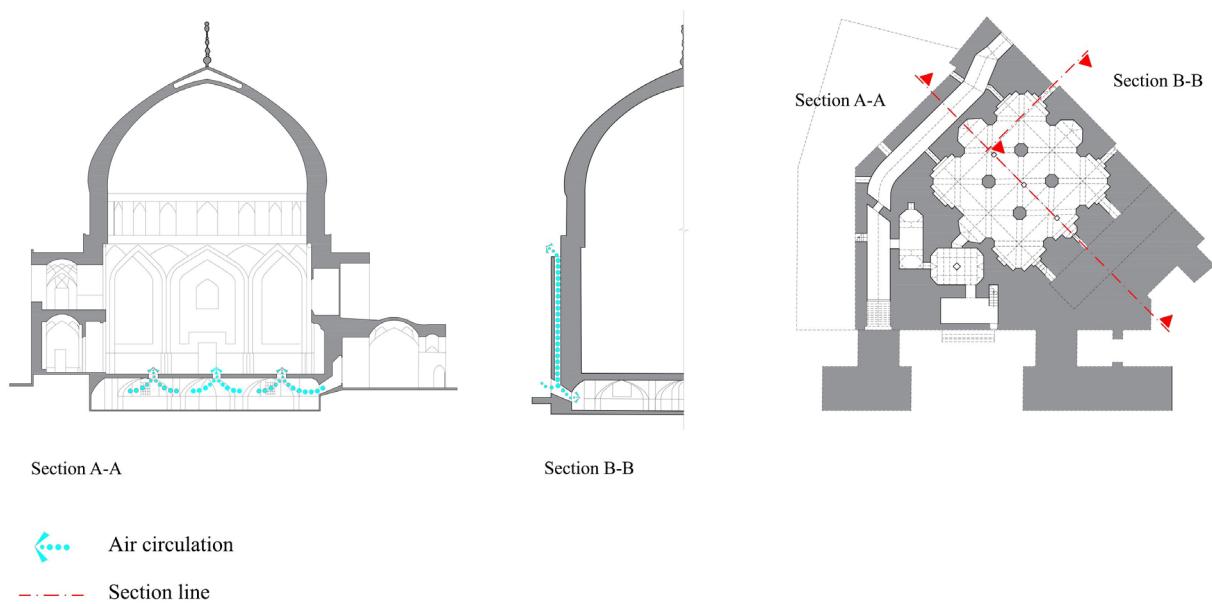
Fig. 4. Right, basement plan; In the middle, section A-A and left, section B-B of the function of the drainage channel in the basement. Source: Authors.

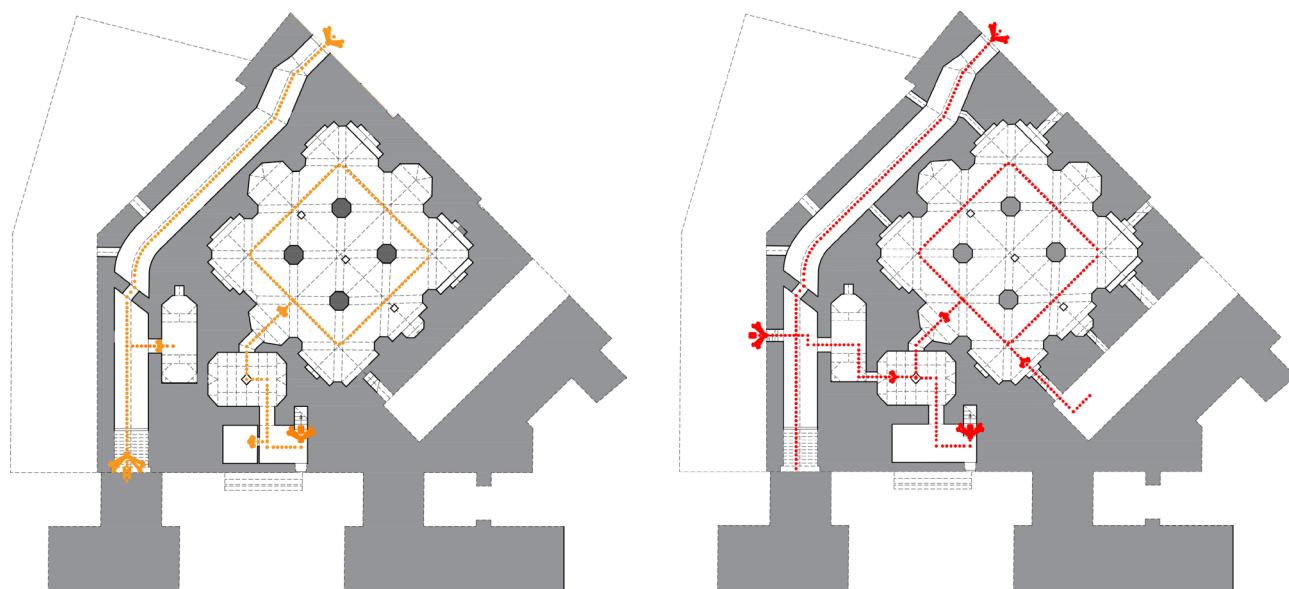
Fig. 5. Changes in the circulation of the basement. Left: Past circulation; Right: Present circulation. Source: Authors.

stored in the basement were executed by Maarefi on the plinths of the basement between 1933-1937 (Cultural Heritage Organization of Esfahan state, 1931; Sajjadi Naeini, 2008, 110; Varjavand, 1977, 4). In 1979, an inappropriate plan for the basement was implemented, due to insufficient knowledge of the building. In this new plan, the function of the basement, which used to be a drainage channel (a large ventilation network), changed to a prayer hall (Fig. 5).

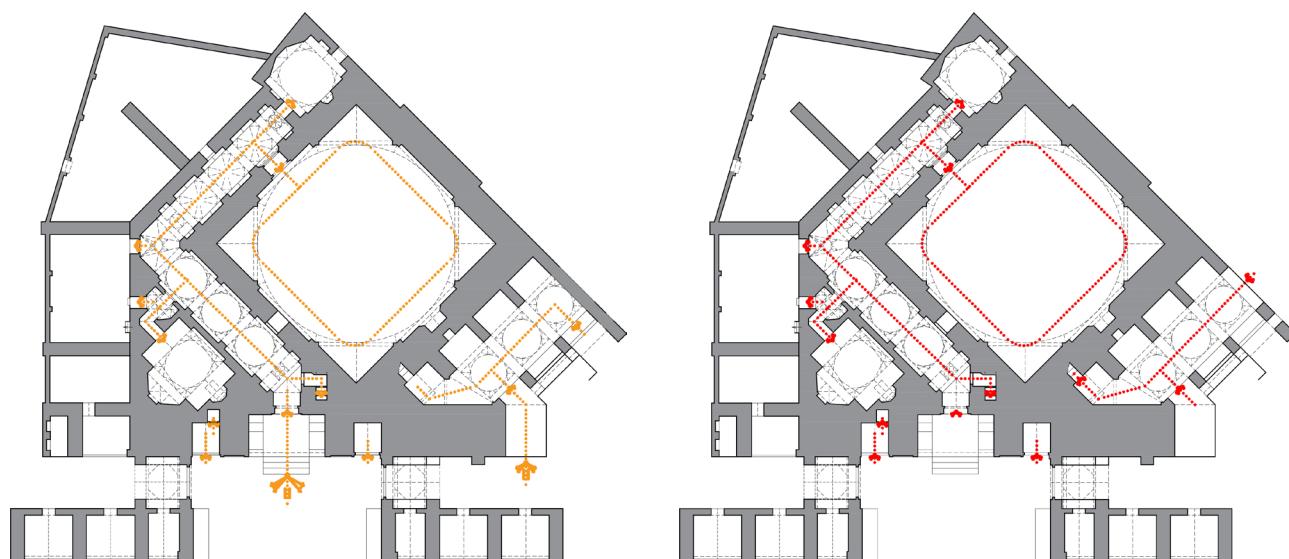
Fig. 6. Changes in the circulation of the first floor. Left: Past circulation. Right: Present circulation. Source: Authors.

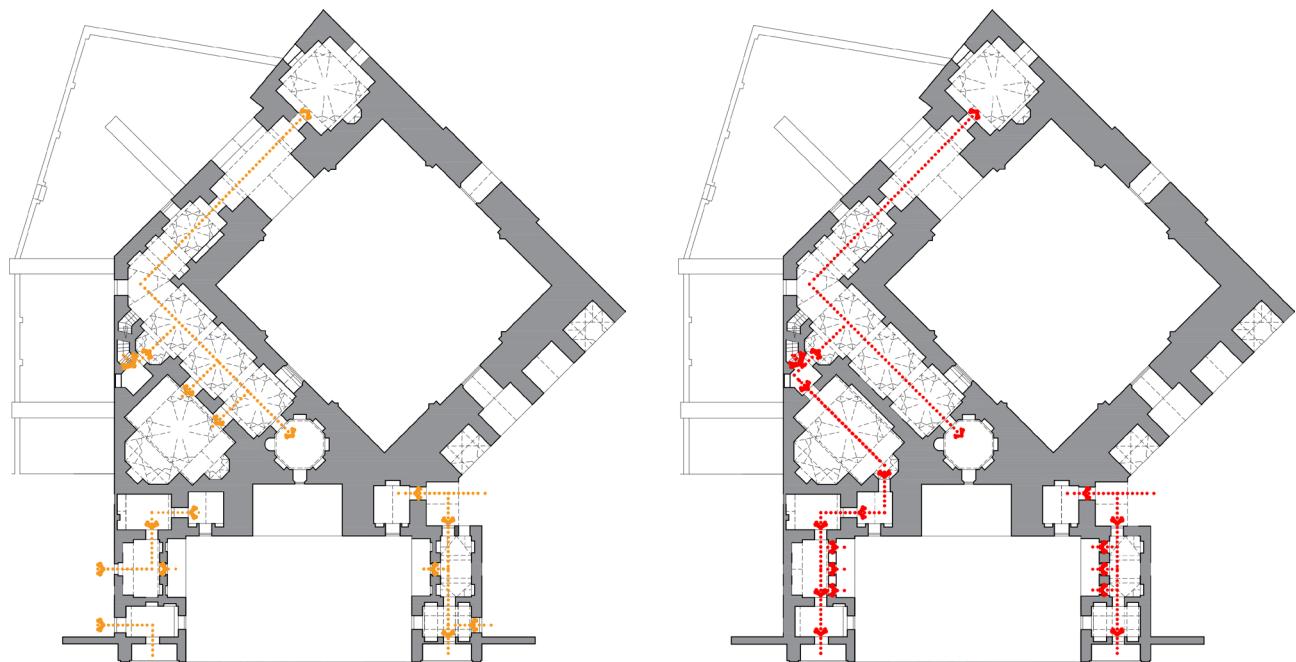
Fig. 7. Changes in the circulation of the second floor. Left: Past circulation. Right: Present circulation. Source: Authors.

There have been various changes on the second floor of the Sheikh Lotfollah monument. So that a completely new circulation has emerged in the building. Many of the original openings of this floor have been blocked and new openings have been created instead. Also, the interior circulation of this floor with the north-facing rooms has been

completely closed. By conducting field studies on this floor, the blocked openings were identified and placed on the map. Therefore, the evolution in the circulation and building plan was drawn and documented (Fig. 7). Unlike the first floor, the second floor is not entirely tiled. However, recently, some parts of this floor have been tiled, inspired by the patterns of the original tiles of the first floor. Another change that can be seen in the historical photos in 1924 is the destruction of the vault in the northeast room of the building. During this destruction, the perforated brick in the window of the second floor collapsed. Today, there are pieces of evidence remaining from the old perforated brick.

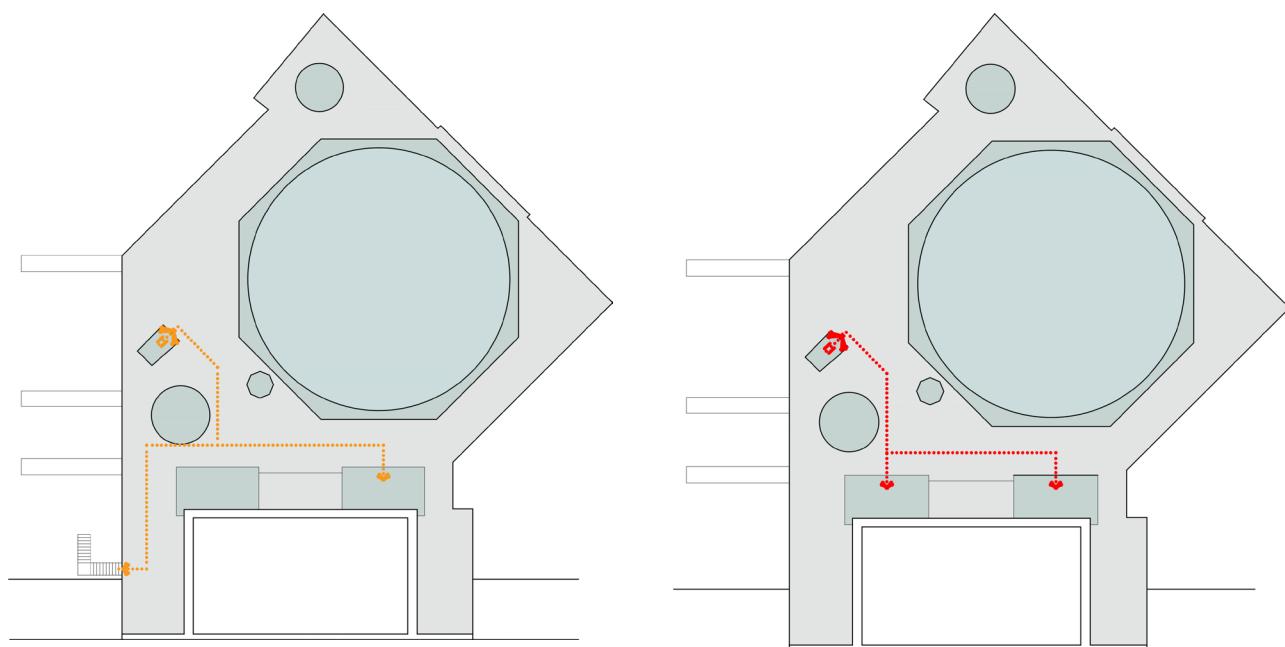
Fig. 8. Changes in the circulation of the rooftop. Left: Past circulation. Right: Present circulation. Source: Authors.

The flooring of the Sheikh Lotfollah monument roof was completely renewed in 1956. There are two rooms on the roof of Sheikh Lotfollah with direct access from the roof. Today, the entrance to one of these rooms is blocked. Also, in recent years, a staircase has been built to connect the roof to the northern rooms on the second floor. Although, there was no such staircase in the

original plan of the building and the access to these rooms was from inside the second floor which is blocked today (Fig. 8).

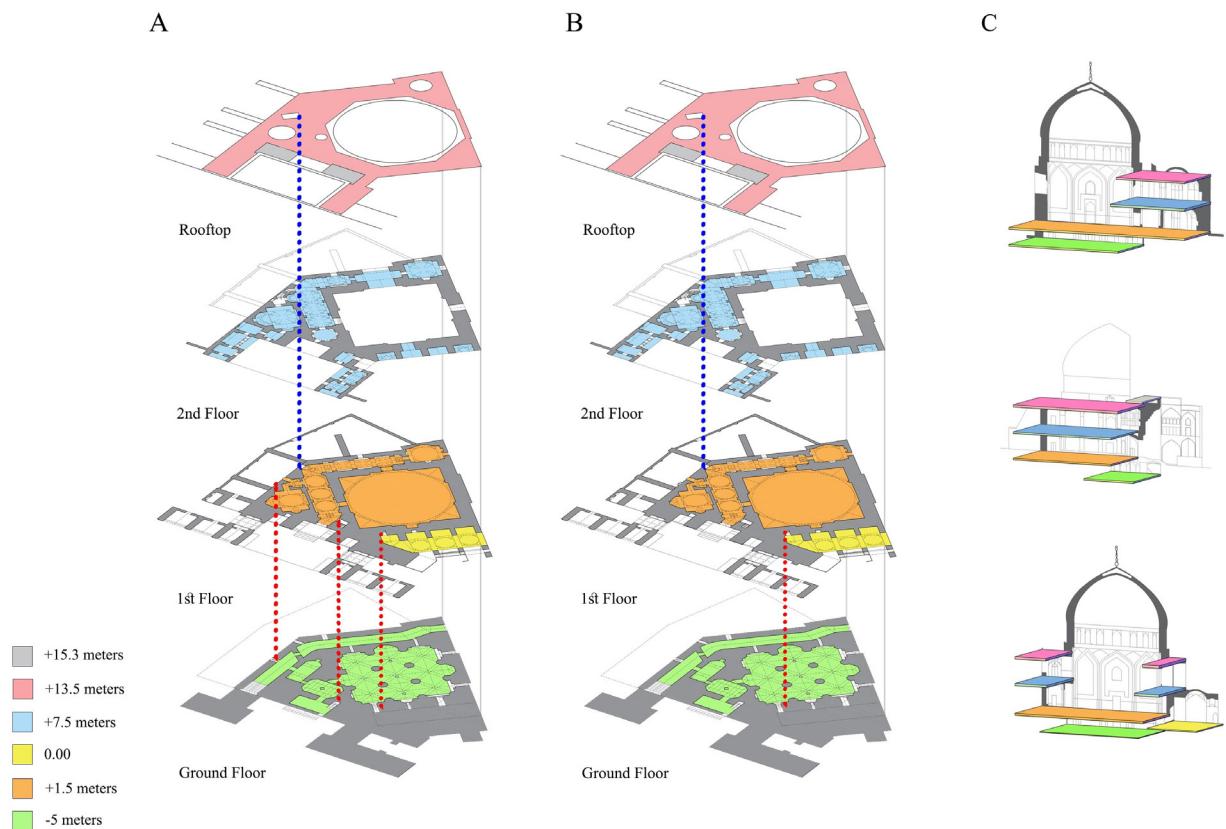
Fig. 9. Changes in the vertical circulations of the building. A: vertical circulation of the past; B: Vertical circulation of the building now; C: Various height levels in the sections of the building. The blocked stairs can be seen by comparison of A and B. Source: Authors.

By analyzing the previous circulation of the building, the relationship between the Sheikh Lotfollah monument and its neighboring buildings (Naghshkhane and coffee shop), which used to be part of the current building, was revealed. It should be mentioned that the building has an important feature that has not been mentioned

so far, and that is the different levels of each floor (Fig. 9). Also, a comparative analysis of descriptive and pictorial documents was conducted along with interviews with restorers and craftsmen and field surveys therefore ultimately all analyzes were presented based on the comparison of all documents with each other.
